Factoria Mall Gets A Whole New Look with Miracote Microtopping

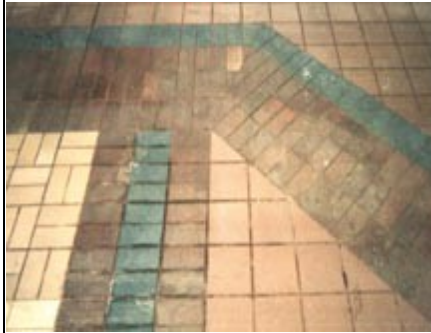
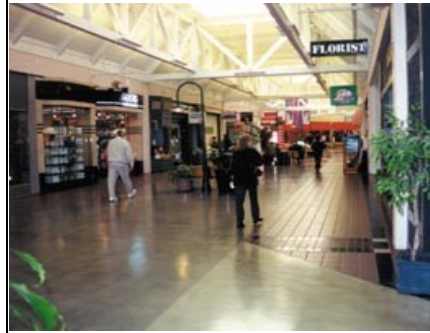
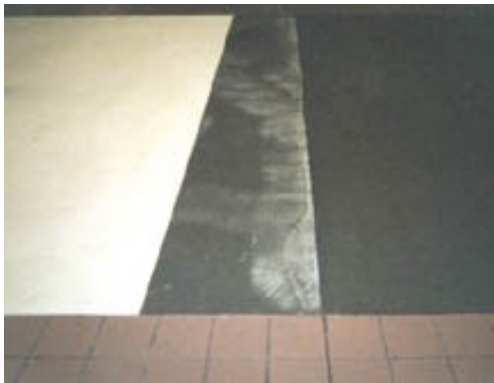
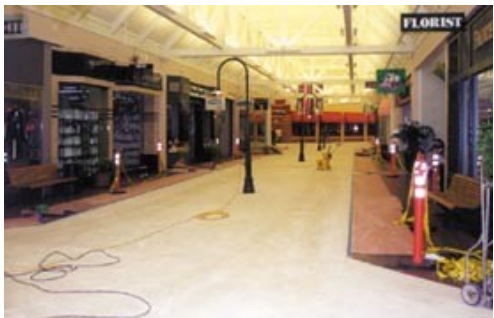
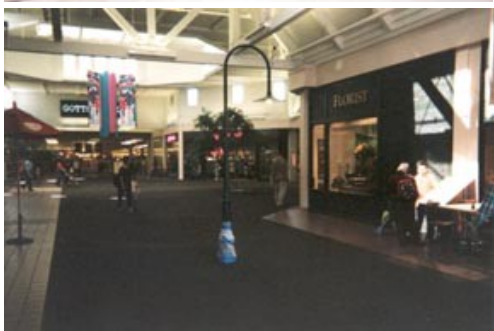
(Before and After pix at right)

Once the tile challenge was resolved, the Architect went to work on design to deliver a welcoming street envisage of leisure life. By incorporating the existing lamps, a main street sprouting narrow entry walkways leading to merchant entrances developed. The application is accented by geometric patterns created using Miracote Microtopping, which consists of a series of integrally pigmented resilient cementitious coats that are saw cut into patterns. Each section is individually treated with a series of four colors using Miracote Mirastain II. This treatment is where the special creative talent of Mr. Buzz Manchester, Bedrock Concrete and his crew really shined. Low maintenance and protection of the applied surface is achieved by application of an epoxy and low odor water based two-component aliphatic polyurethane sealer. The job, approximately 37,000 square feet, required just less than three weeks.
